Wynndel Community Center  
5127 Wynndel Rd  
Wynndel, BC, V0B 2N2

Project No. 2025-021  
Date: 2025-03-11

**Re: Structural Condition Review Report  
Wynndel Community Center  
5127 Wynndel Rd, Wynndel, BC**

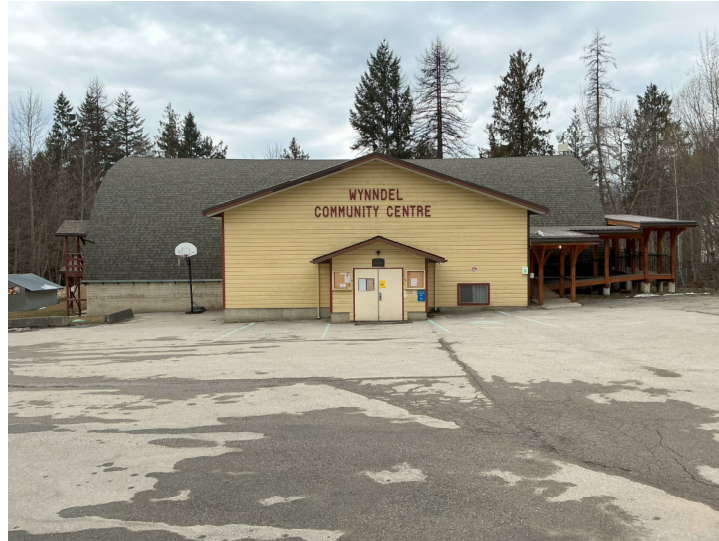
Photograph 1: Exterior east elevation view

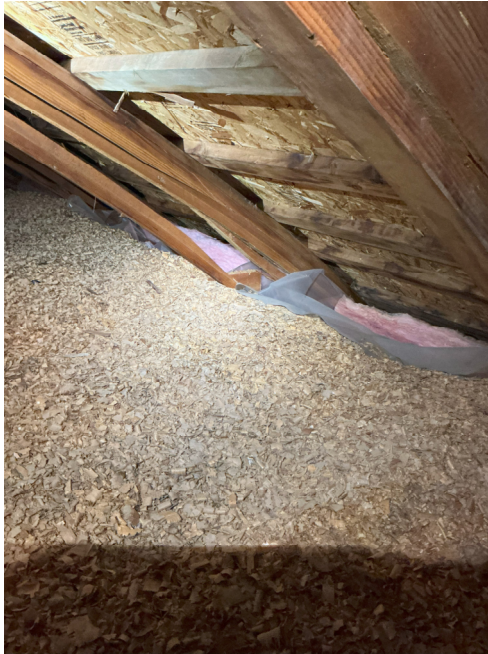
The majority of the glulam arches (16 out of 24) were observed to be in very poor / failing condition, with significant delamination and cracking / broken plies observed. (6) of the (8) glulam arches that were observed to be in reasonable condition were located at the southernmost end of the building, and the remaining (2) glulam arches that were in reasonable condition were located at the northernmost end of the building. The majority of the damage observed to the central arches was located on the west side of the building, although some damage to the arches was also observed on the east side of the building. In addition, the 2"x6" horizontal members supporting the ceiling between the arches was observed to have sheared away from the arches on the west side in several locations.

Photograph 2: Cracked / broken glulam arch

The client indicated that they believe the east addition was constructed circa 2001, and that the roof cladding of the original building was changed at approximately the same time. It is worth noting that a common cause of structural failure for an arched roof system is when the arches are subjected to unbalanced loading (more snow on one side of the arch than the other). In fact, changes were made to the National Building Code of Canada (NBCC) in the 1970's to address this issue as the previous loading conditions specified in the code were deemed to be unsafe for arched roofs. Construction of the east addition would directly contribute to unbalanced snow loading, as snow shedding from the arched roof would be able to accumulate against the arched roof at the intersection of the east addition roof.

It is also worth noting that the original arched roof cladding was constructed of metal sheeting and that this cladding was replaced with asphalt shingles. Metal sheeting is considered a slippery surface that readily sheds snow, whereas the asphalt shingles would likely not shed snow as easily. This change in roof material could have contributed to additional snow remaining on the surface of the roof, increasing the overall load supported by the roof structure.

- 1. Roof & Wall Structure – Original Building: It is the opinion of Bolen Engineering that the existing glulam roof arches of the original building are currently in a state of structural failure and collapse of the structure is likely imminent. It is also the opinion of Bolen Engineering that the components of the roof and wall structure that have not failed are**

likely undersized and would not meet the loading requirements of the current edition of the BC Building Code. Due to the extensive damage to the roof arches, combined with the undersized structural components, it is the opinion of Bolen Engineering that structural repairs to the existing arch system would be extensive and are likely not economically feasible. It is the recommendation of Bolen Engineering that the existing arch structure be removed and replaced with a new structure meeting the current requirements of the BC Building Code.

2. **Occupant Safety:** It is the opinion of Bolen Engineering that the observed structural failure of the arched roof system over the original building has resulted in a significant risk to occupant safety within the building. It is the recommendation of Bolen Engineering that until repair or reinstatement of the building structural integrity is complete, no person be permitted to enter the building. In addition, in order to minimize additional damage, it is the recommendation of Bolen Engineering that no snow or rainwater be allowed to accumulate on the roof. It is also the recommendation of Bolen Engineering that the owner monitor the building until repair/reinstatement is completed. Should any signs of further structural distress or displacement be observed, Bolen Engineering should be contacted immediately for review.

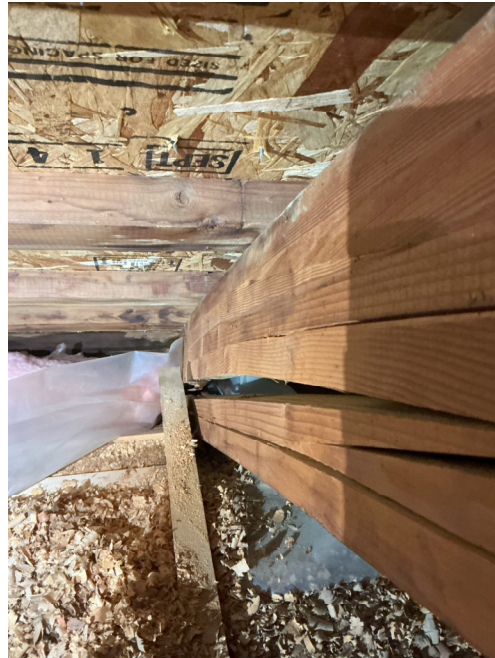
Photograph 3: Cracked / delaminated arch

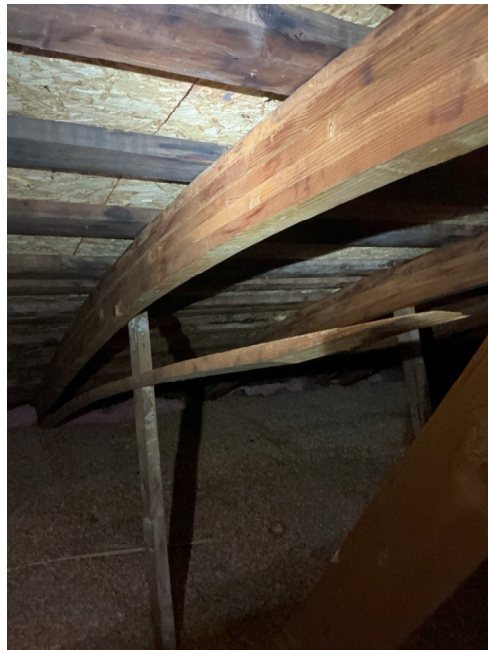
Photograph 4: Broken glulam arch

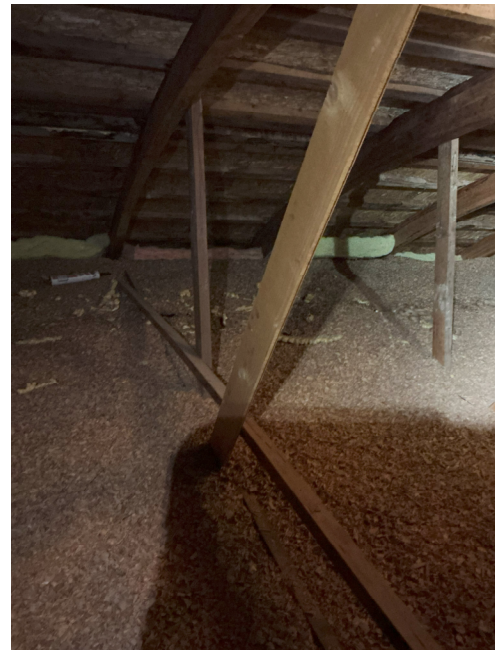
Photograph 5: Broken arch & ceiling support  
(lower horizontal piece is broken off arch)

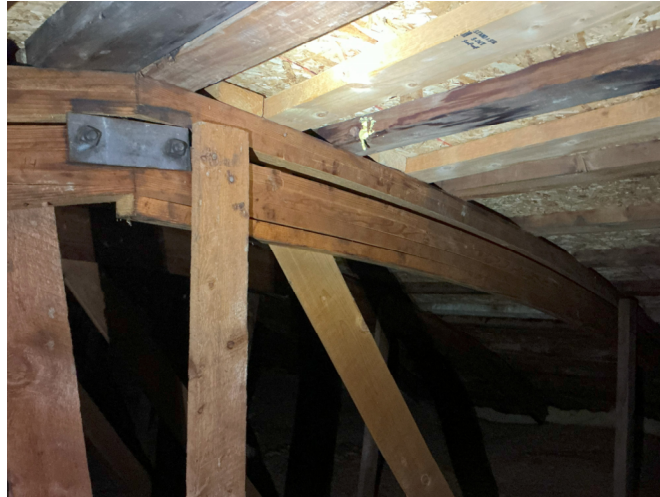
Photograph 6: Broken / delaminated arch at peak connection

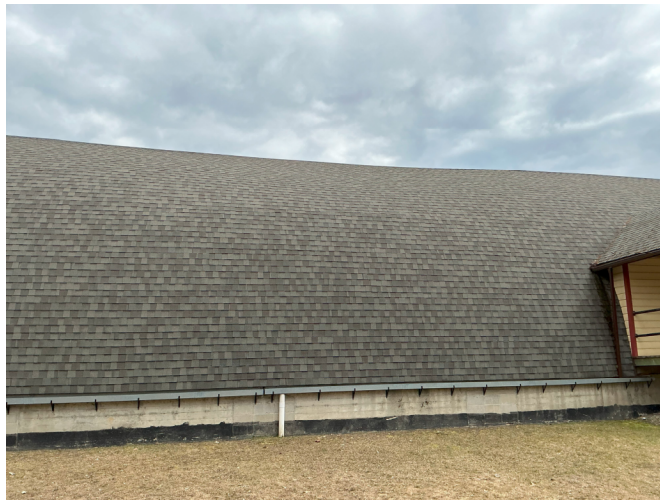
Upon reviewing the roof structure from the exterior on the west side of the building, the roof surface was observed to have experienced displacement of the roof profile, with bulging and undulations noted across the roof surface, particularly in the mid-section of the building.

Photograph 7: Bulging / alteration of roof along central portion of west side

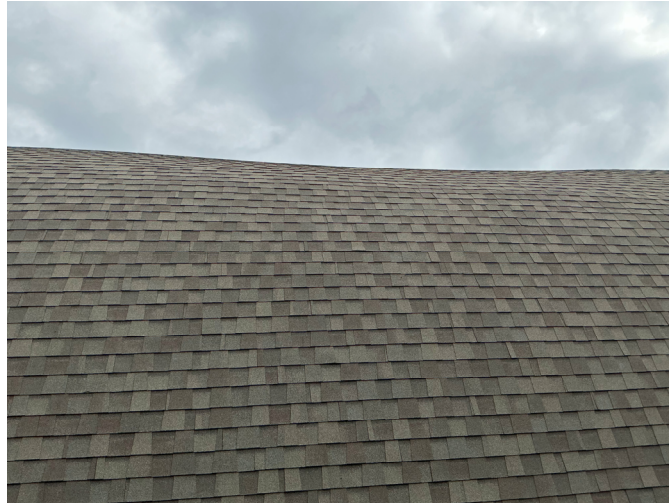
Photograph 8: Bulging / alteration of roof along central portion of west side

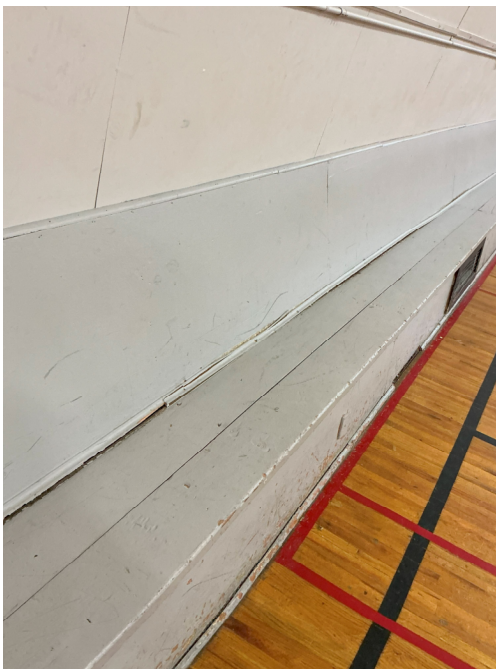
The majority of the glulam arches below the ceiling forming the wall structure of the building were concealed by interior and exterior finishes at the time of our review. As such, a structural review of the arches within the walls could not be completed. However, a visual review of the interior finishes showed several signs of cracking and displacement, particularly at panel edges and along the seams of the benches built into the walls.

Photograph 9: Splitting / displacement at back of bench

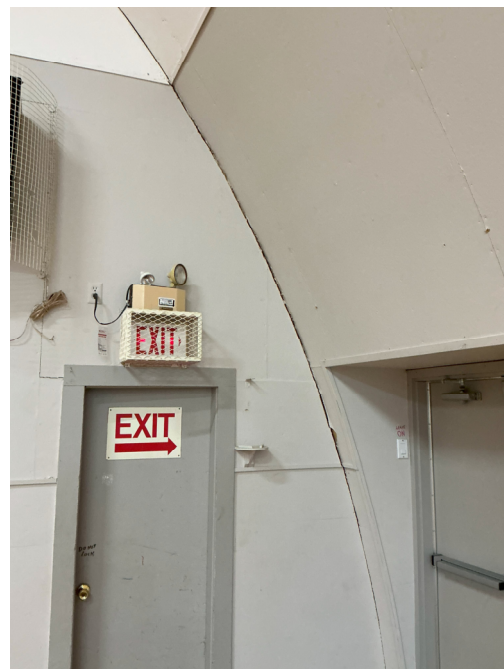
Photograph 10: Displacement at southwest corner

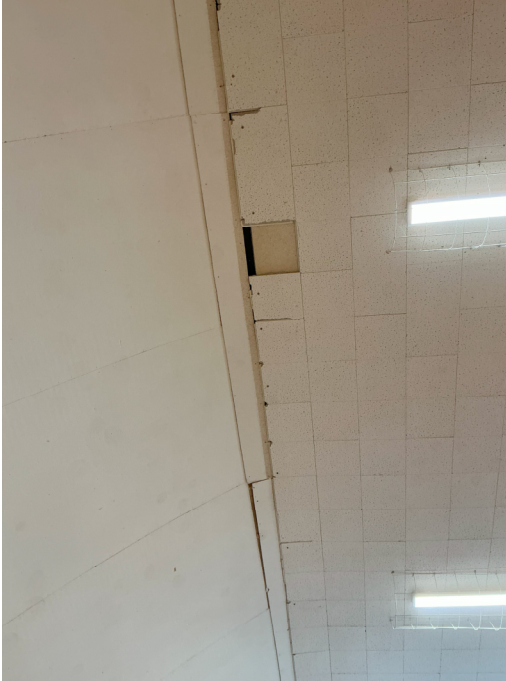
Photograph 11: Finishes pulling apart at ceiling

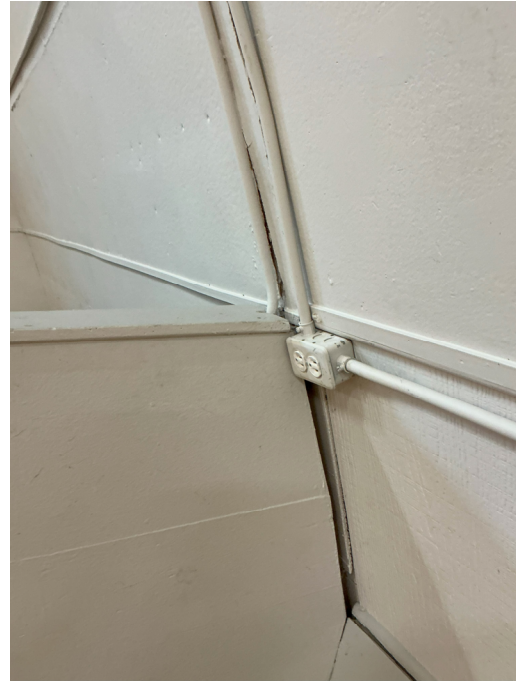
Photograph 12: Wall displacement away from conduit
